NASA TN D-6721

APOLLO EXPERIENCE REPORT - WINDOW CONTAMINATION

by L. J. Leger and R. W. Bricker

Manned Spacecraft Center

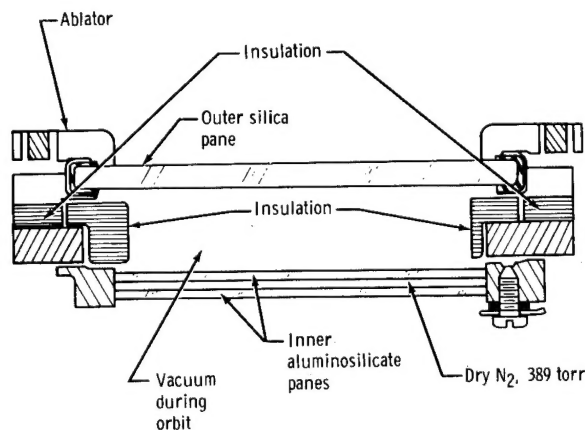
Figure 4. - Detail of CM hatch window 3.

During the maximum heating conditions of the test, the maximum temperature that was measured for the nonmetallic materials was 87°C , whereas the temperature of surface 2 of the hatch window attained -20°C in the cold conditions of the test. A small amount of contamination was noticed during a short portion of the first cold-soak period of the hatch test. The contamination disappeared early in the first heating cycle and did not reappear. This phenomenon had been noticed in earlier tests and was attributed to water vapor trapped between the heat shield and the pressure-vessel structure. Post-test infrared analysis of the hatch-window surfaces indicated no detectable contamination.

To verify that vacuum baking was an adequate solution for full-scale windows, an Apollo hatch was assembled from baked components and was tested in a large vacuum chamber. Heating was provided by a solar lamp and supplemental infrared heaters. The hatch was tested under simulated earth-orbital thermal conditions and under conditions of maximum heating that may be encountered in a maneuver such as an attitude hold for docking purposes.

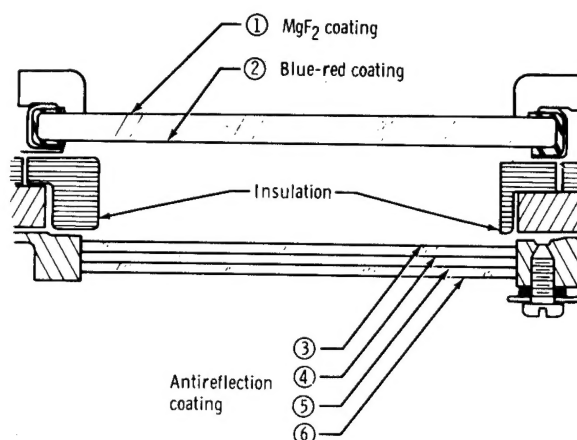
Figure 5. - Command module window-surface notation used in contamination locations.

During jettison of the launch escape tower and boost protective cover, a light gray film was deposited on surface 1 of the Apollo 7 windows. Although this condition was not reported on any of the other flights, it may have contributed some window contamination on all flights.

Soon after earth-orbital insertion, a film appeared on surfaces 2 and 3 of the hatch and side windows of the Apollo 7 and 8 command modules. This contamination continued to accumulate during flight and resulted in a heavy film in some locations and droplet formation in other locations. A photograph, taken with a camera focused on the hatch window during the Apollo 7 mission, is shown in figure 7. During the night pass of the spacecraft in earth orbit and during other similar cold-window conditions, the contamination seemed to crystallize and become opaque, particularly on the hatch window.

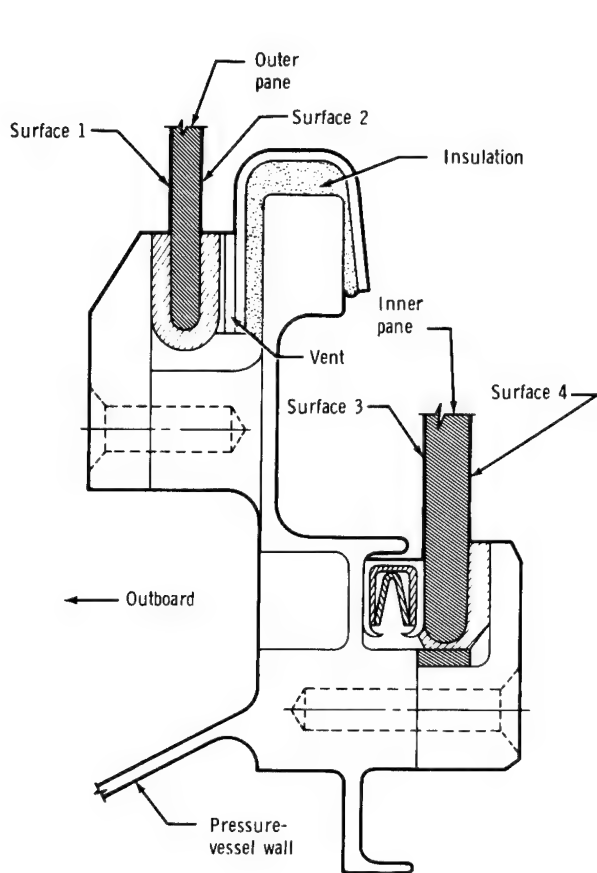
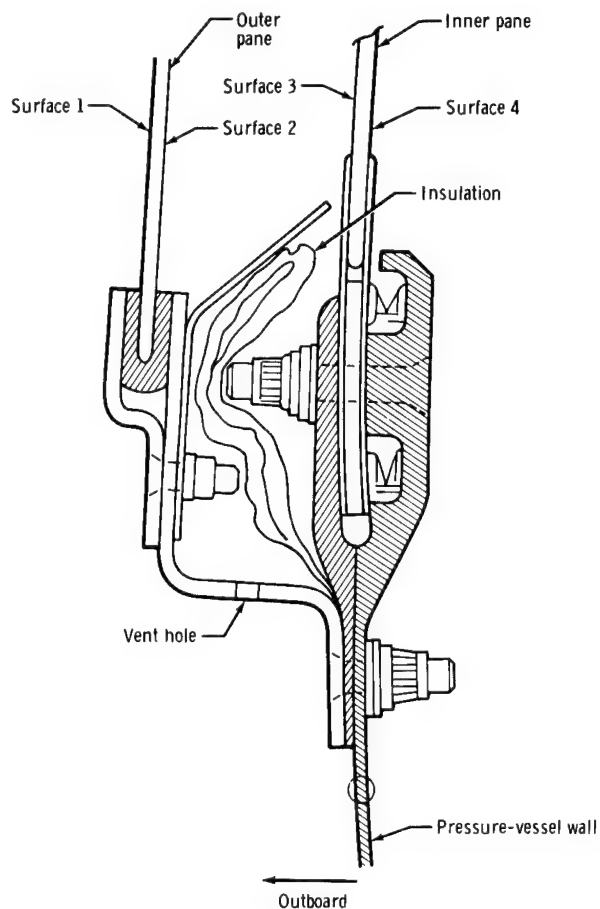
The relatively contamination-free condition of these windows might seem surprising because it was indicated earlier that the weight loss of the materials that were used in construction was rather large in some instances. However, if table II and figures 15 and 16 are examined, it is clear that the materials that sustain large weight losses are used in very limited amounts and, in general, are not exposed to the area between the panes. There is one exception: the fiber-glass retainer that involves an epoxy as the matrix material. The weight loss for this material was 0.65 percent. Because no contamination problem was encountered, the amount of condensable outgassing products from the epoxy was assumed to be very low.
